CATHODIC PROTECTION SYSTEM

FOR FLEET MOORINGS

CATHODIC PROTECTION SYSTEM FOR FLEET MOORINGS

Technical Report R-702

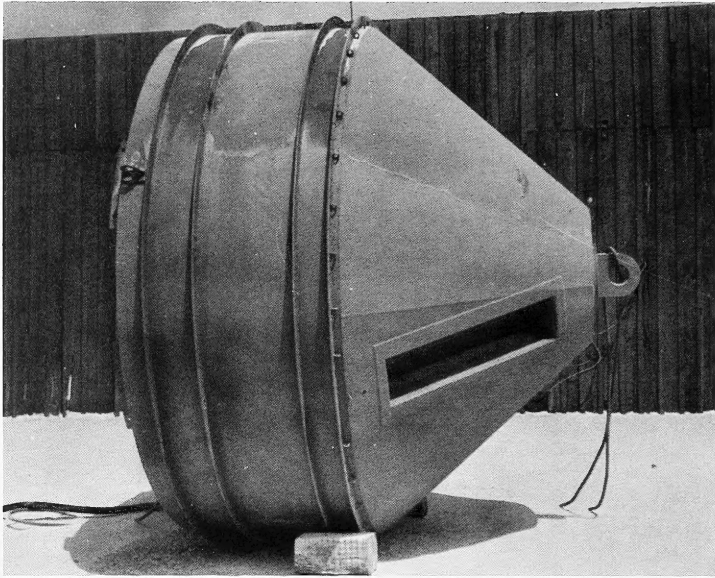
Figure 2. Test mooring buoy during sandblasting.

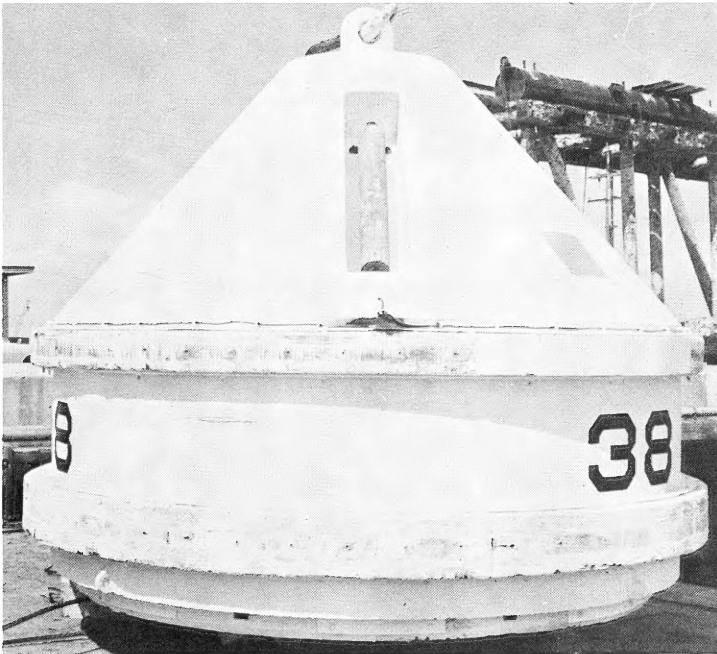
Figure 4. Inverted test buoy showing the square-foot area of bare steel on lower left of cone and location of the ground cables.

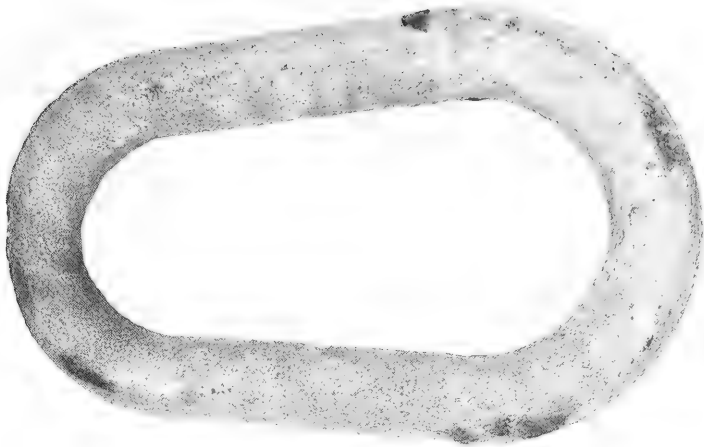
The total cost for rehabilitation of the control mooring amounted to \$4,617 of which \$2,000 was for pickup and installation and \$2,617 was for repairs. The unprotected ground ring assembly was loose, and all rivets needed replacing. The pear links were badly pitted, and the thickness was reduced in places to 1-1/2 inches (a loss of 40%), necessitating their replacement (Figure 13). The chain thickness for the first five links on all legs had been reduced to about 1-7/8 inches.

Figure 13. Pear link from control mooring showing pitting and greatly reduced thickness.

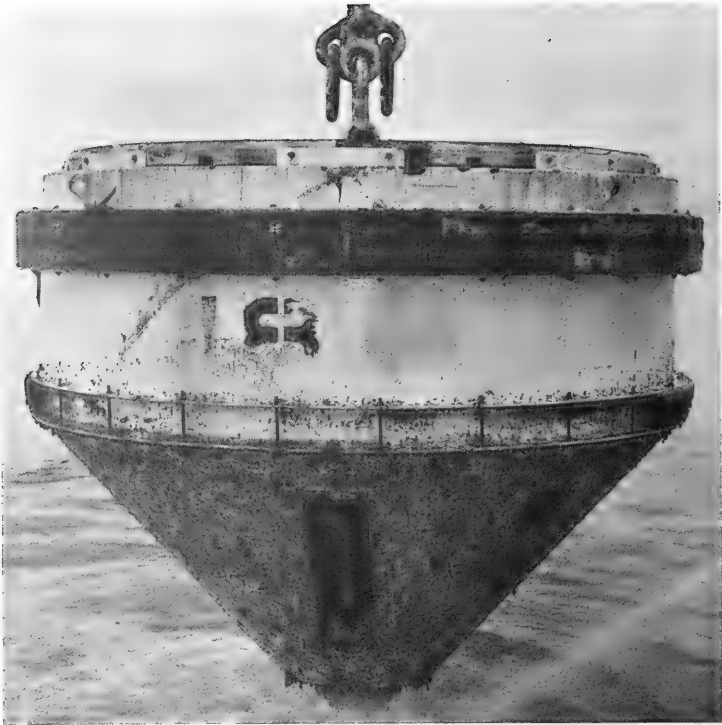
Twenty-three months after relocation of the cathodically protected mooring, the buoy was lifted from the water for its annual inspection. The buoy and the entire riser-chain was hosed with seawater (Figure 16) to remove the attached fouling organisms. The buoy had lost about half of its lower fender from marine borer attack. There was very little coating damage

(mostly from abrasion) and no detectable rusting of steel below water except for the square of exposed steel that had a hard tight film of rust but no pitting or active corrosion. Rather heavy marine fouling had accumulated since the buoy was washed 1 year earlier. Fouling included tunicates, barnacles, green algae, mussels, and tube worms.

Figure 16. Cleaned buoy 23 months after relocation. Note the lost section of lower fender, the anode in the sea chest, and the square of bare steel.

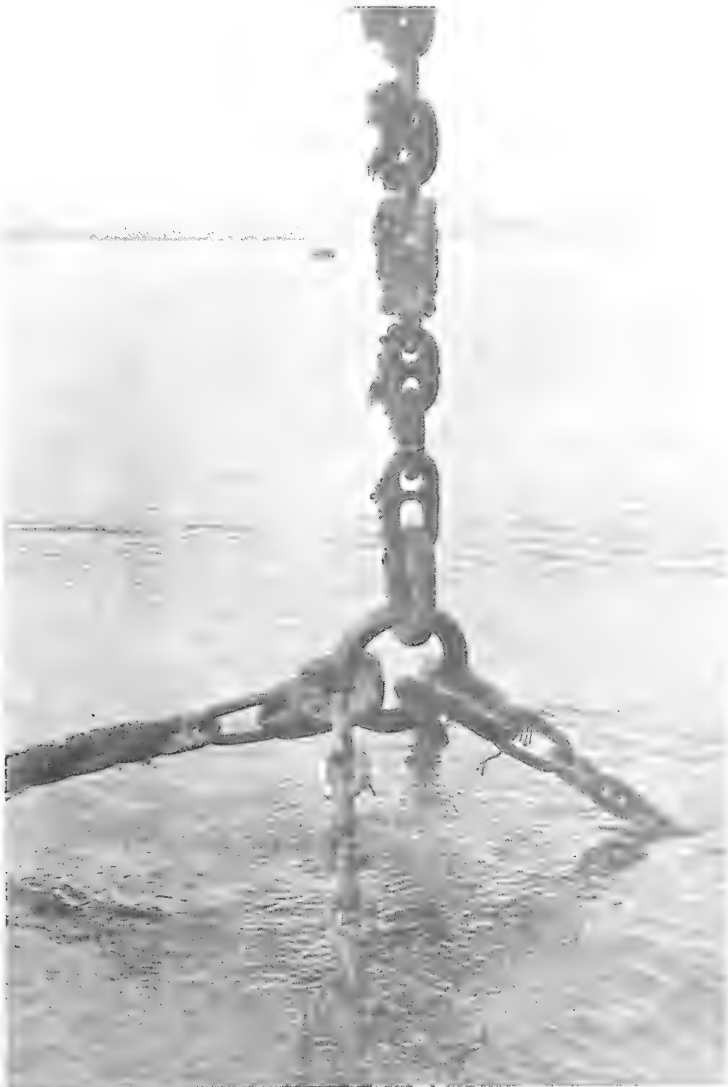
About one-third of the zinc anodes in the sea chests had been lost, and only about one-tenth of the zinc anodes on the riser-chain (Figure 17) had been lost. The divers who assisted in measuring the potentials indicated that the anodes on the ground legs were in a similar condition.

The riser-chain and ground ring assembly were in excellent condition (Figure 17) with no apparent corrosion. The chain diameter remained at 2-1/2 inches. The ends of the four steel cables that terminated near the ground ring had been pulled loose from their connections to the chains. Welds had been broken from two of the legs, and the cables had been pulled from the cable clamps that remained on the other two legs. This area still had sufficient electrical continuity for complete cathodic protection.

Figure 17. Ground ring assembly and riser-chain with anode 23 months after relocation.
